## Chicago: Anatomy of a Building and its Collapse

Issued: December 27, 2010

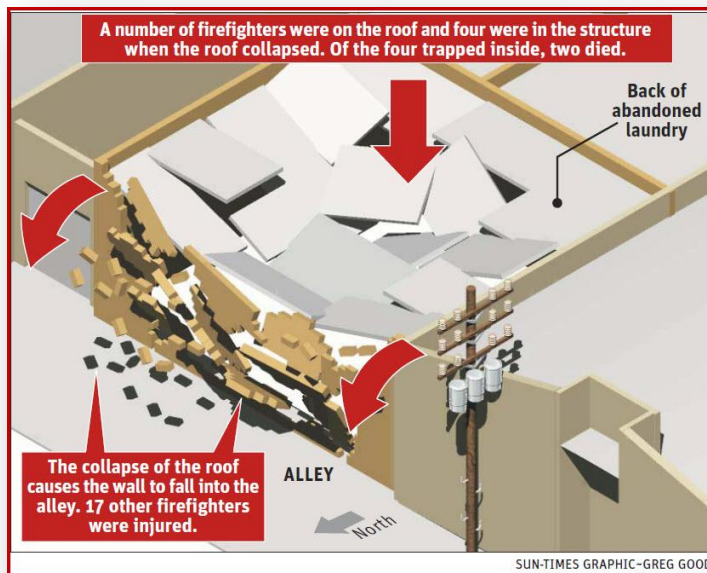
Non-Bearing Sidewall lateral "push-out"/ outward" collapse resulting from the inward failure of the roof system into the interior

The inward momentum created by the downward force of the failing roof area, pushed outward the entire north wall face, which based upon the modular characteristics of the brick and mortar, most likely caused the wall to collapse in sizeable sections (outward collapse as well as disintegrate into smaller projectiles with a classical curtain failure). Photos suggest the wall failure resulted in a collapse zone that spanned the entire narrow alley way from wall to wall (estimated at 18 +/- feet) leaving no room to escape the lateral failing wall collapse without running in an east and west direction only.

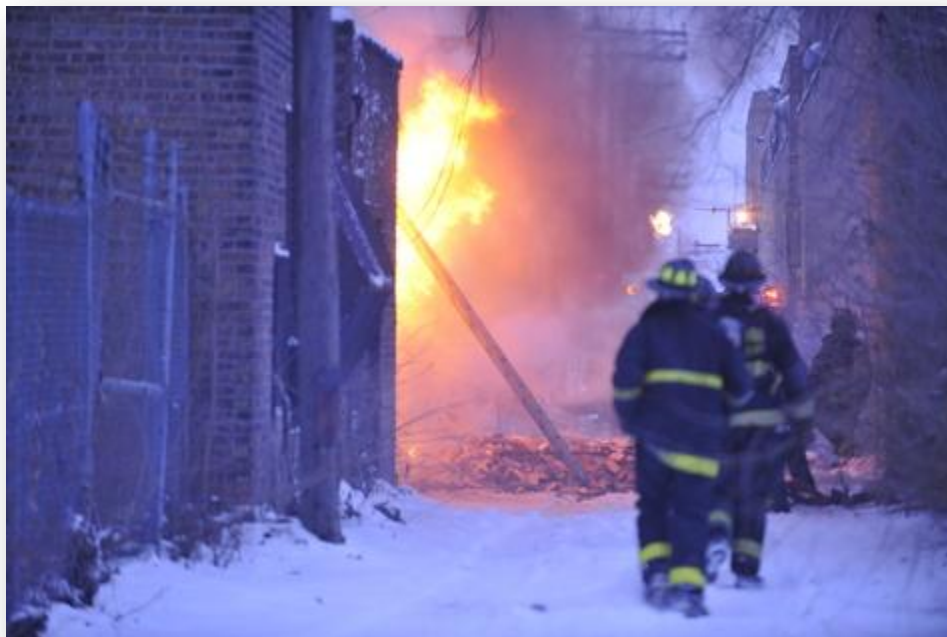
Operations in the Charlie Side Alleyway

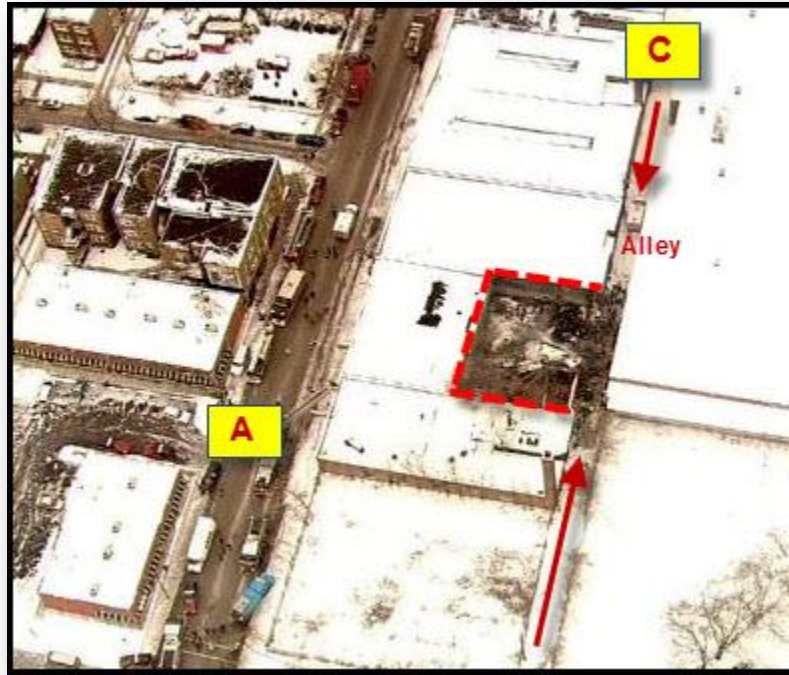
Aerial Photo of the Collapse Zone looking from the Delta Side.  
The Rear alleyway on the Charlie Side runs parallel to East 75th Street.

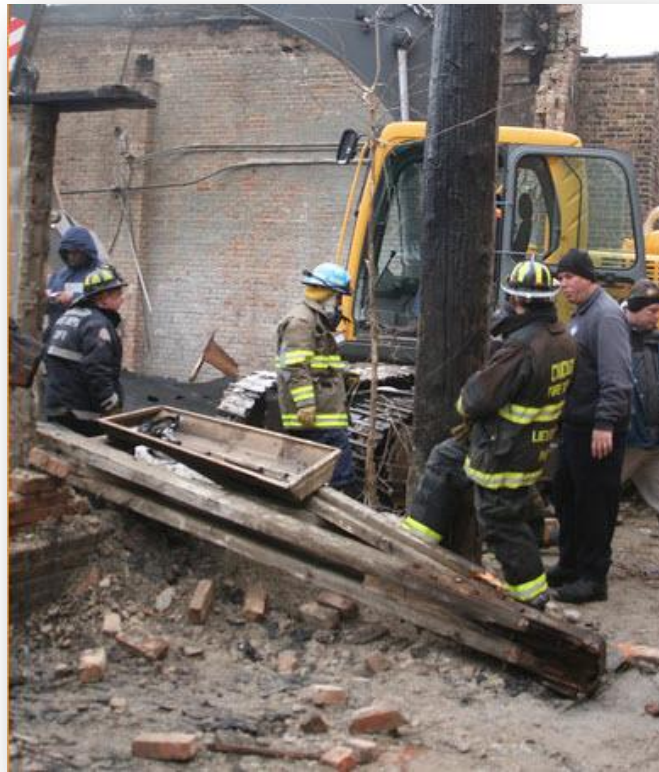
This is evident in a series of fireground photos that clearly depict the remnants of a shallow depth built-up chord bowstring truss comprised of timber wood components.

**Built-up Bowstring Timber Truss Component**

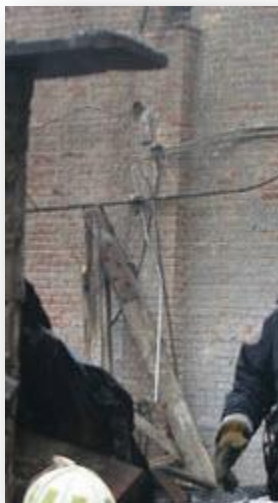
**Truss resting along an interior support pilaster Bearing End of Bowstring Truss Component**

It appears the bowstring wood truss components rested on top a series of four (4) brick wall pilasters and pocketed within the east and west brick bearing walls. The north non-bearing brick wall appears to be a three wythe solid brick wall, with the bearing walls running east-west. The non-bearing brick wall running parallel to the alley way was the portion of wall that collapsed outward as a result of the inward collapse of the truss roof support system, wood rafters and plank roof deck.

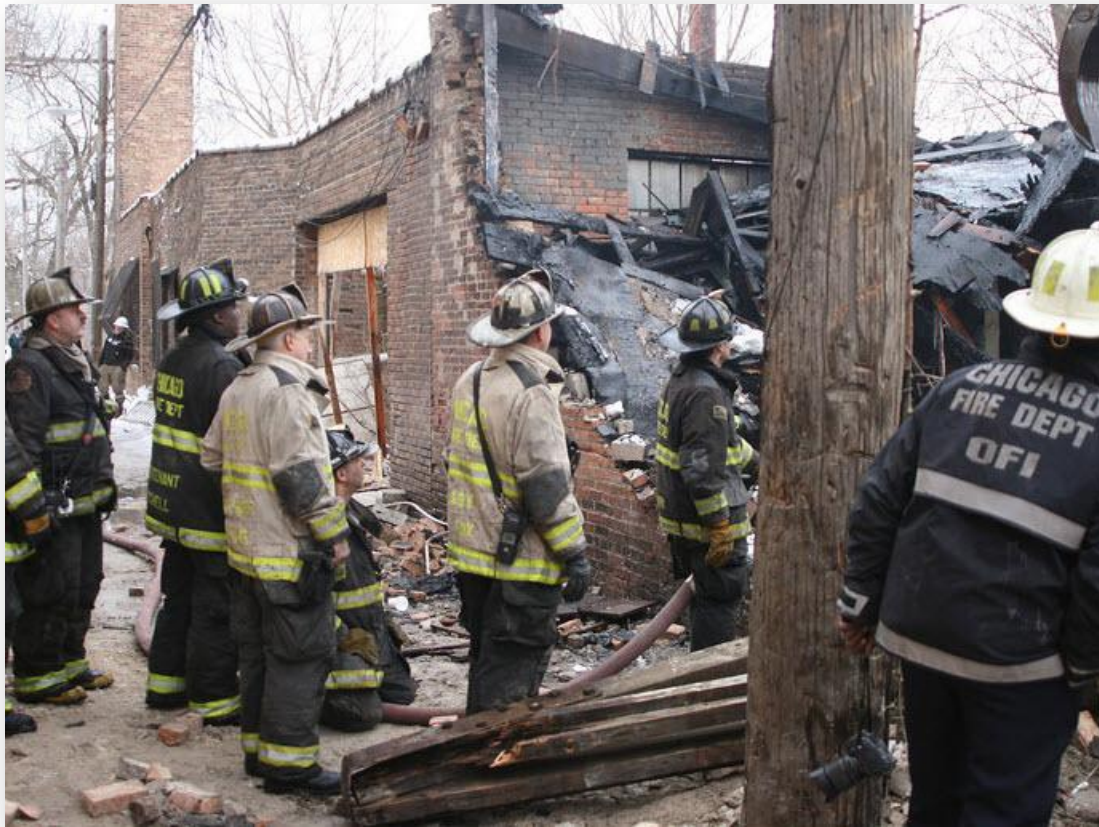
#### **Bearing End of a built-up Bowstring Chord Truss**

- The loss of load bearing and load transfer capabilities at the wall connection can contribute towards failure and collapse conditions. The end connections points (cap or shoe) of a bowstring truss are critical towards maintain truss performance and structural integrity.

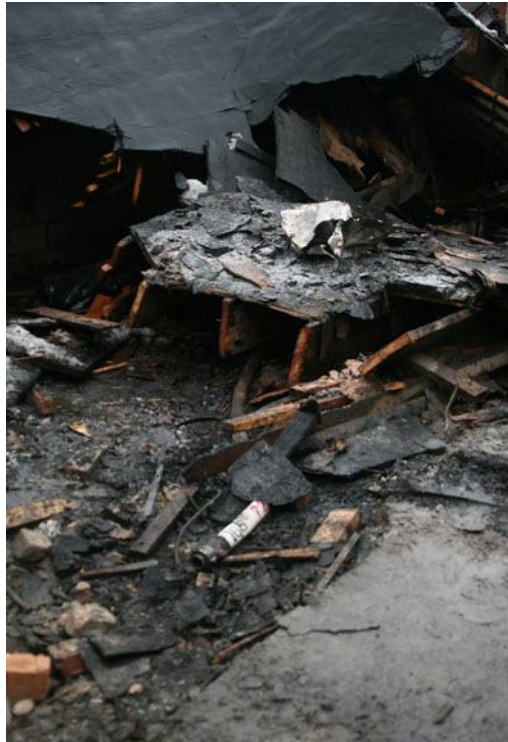
**Wood Roofing Planks and outer membrane with visible Wood Roof Rafters as part of the Roofing System**

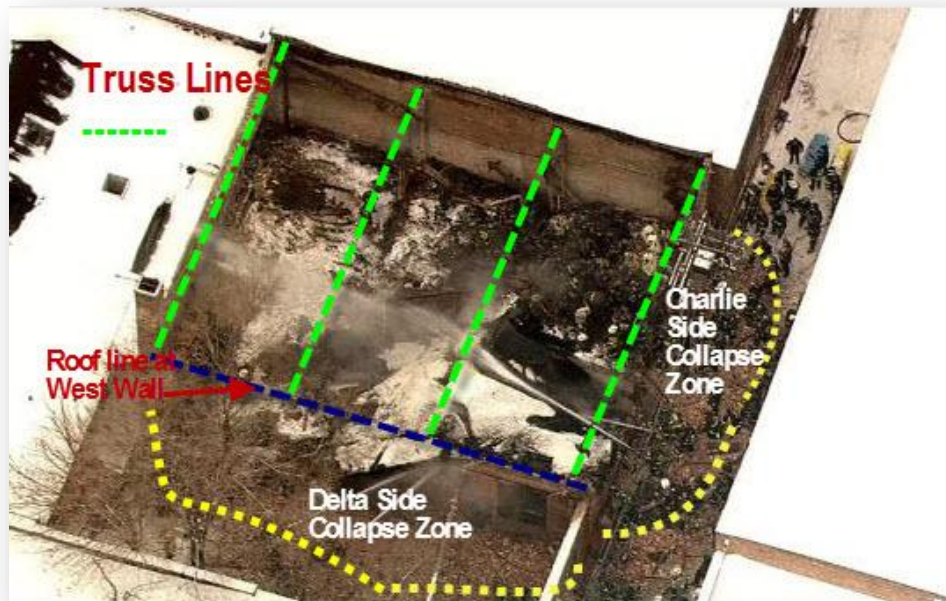
**Truss Orientation and Charlie Side Collapse Zone**

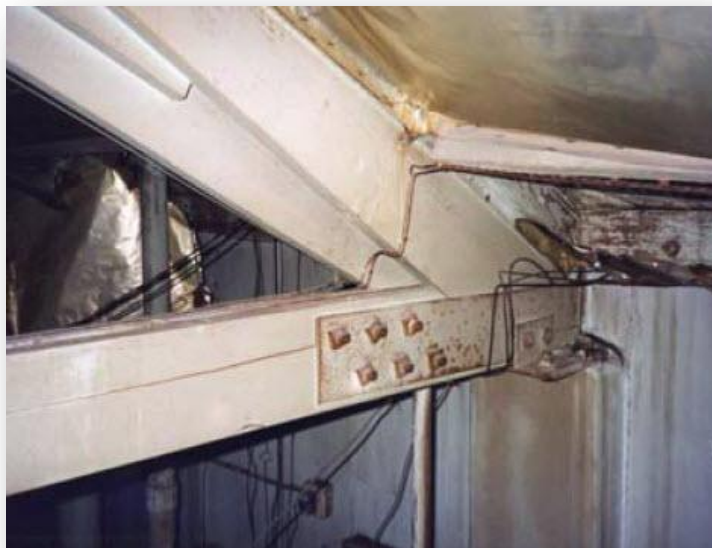
These load bearing points are susceptible to age related deterioration of the bearing surface, shoe connection/chord connection, loss or degradation of the bearing wall conditions, decay or deterioration of the end connections that adversely affect the structural stability of the top truss cord to transfer the thrust loads imposed upon this connection into the bottom chord.

**Typical Truss End w Bottom Chord, Steel End Shoe and Load Bearing Plate on a Pilaster**

***Note: the crack in the bottom wood chord running from the steel shoe and bolt connections, indicating an area of concern***
