Got Fire? Anticipate Collapse....

Christopher J. Naum, SFPE

Issued: November 9, 2011

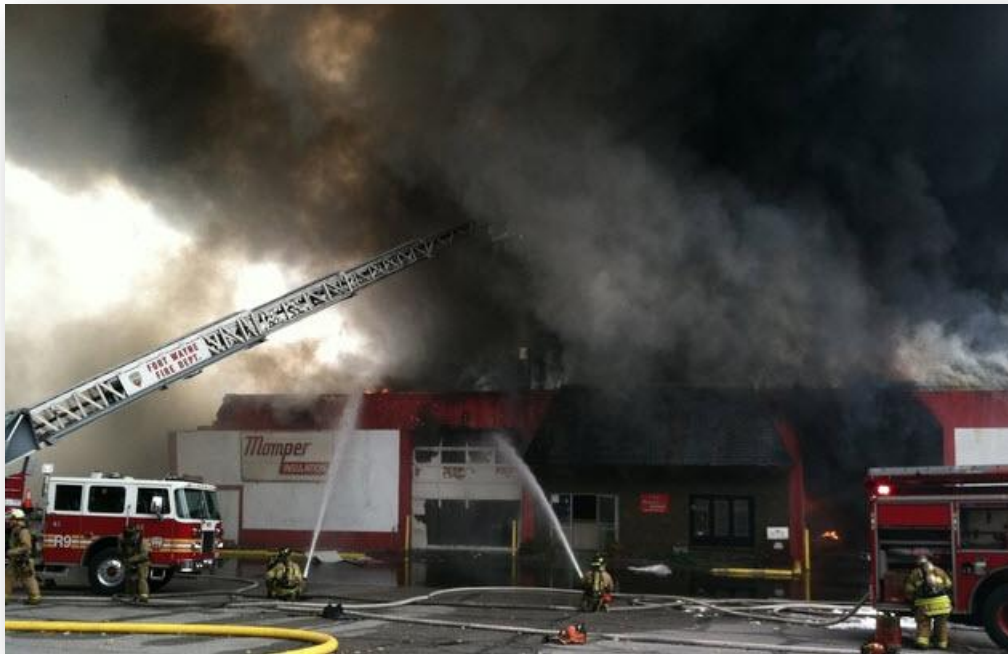
Four Alarm Commercial Building Fire with Collapse: Fire Photo by Ben Goldberry

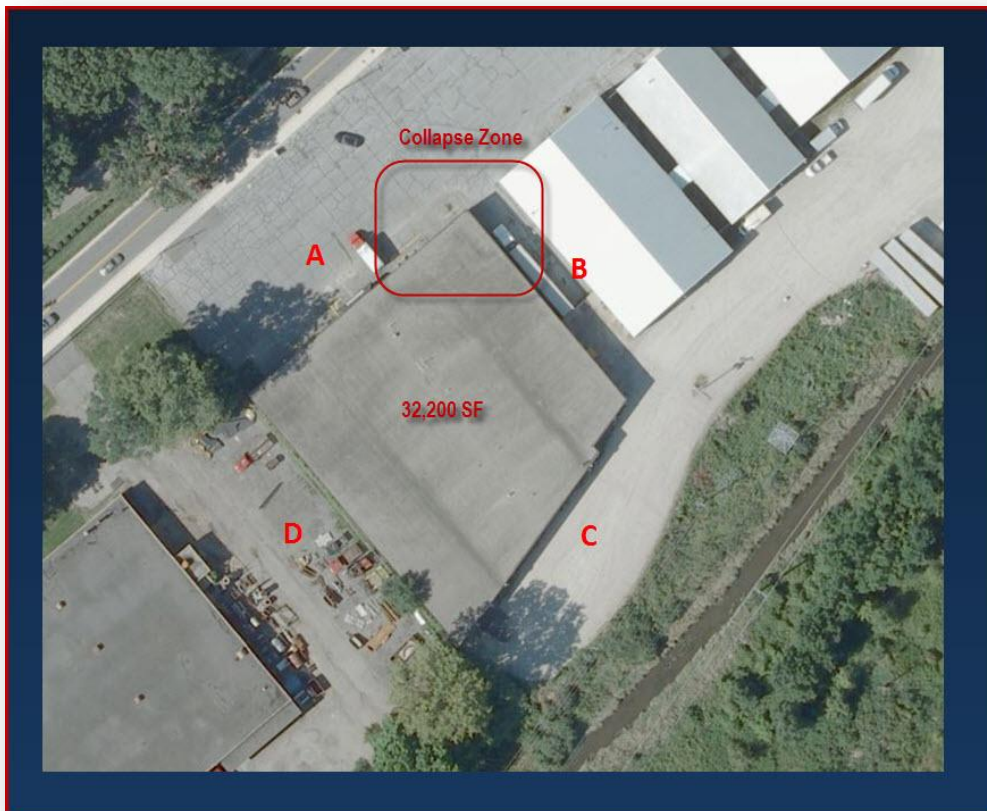
Aerial Plan of Building and Collapse Area A-B

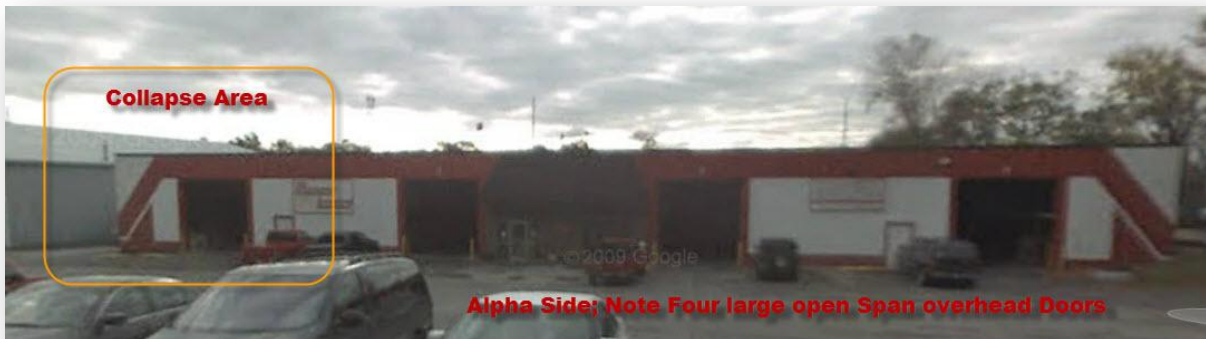
Alpha Street Side View- Adapted from Google Street maps

The view of the alpha street side identifies the building front facade, its main office entrance (center between dual overhead doors on the left and right). Pronounced on the alpha side facade is the presence of four (4) equally spaced overhead (OH) doors that provide direct access into the building's interior. The subsequent collapse area is depicted at the A-B corner with special attention drawn to relationship of the wall plane and OH door proximity.

The relationship and this wall surface (area square footage) and the presence of the OH door opening to the wall/ roof interface area that subsequently became compromised and collapsed is critical in further understanding the mechanism of the collapse sequence and also the positive effect it had on the survivability of the firefighters who were within the collapse zone at the time of the wall failure.

In this instance (as shown in the Alpha side street view), the presence of the large overhead door in close proximity to the corner wall intersection and transition (A-B side), actually makes this position, fireground proximity and travel paths highly prone to early and complete collapse potential in the event of a loss of the wall-roof component or assembly integrity or in the load bearing/transfer capabilities of the wall-roof assembly.

- ***The presence and identification of a corner configuration similar to this in a commercial structure should result in a higher degree of considerations and risk assessment when formulation and deploying operational assignments and in the placement of personnel for task assignments in this proximity.***
- ***This operational area should be considered as a candidate for designation as a collapse zone based upon projected or defined operational considerations, incident conditions and predictive building characteristics, systems, materials and fire dynamics and conditions.***

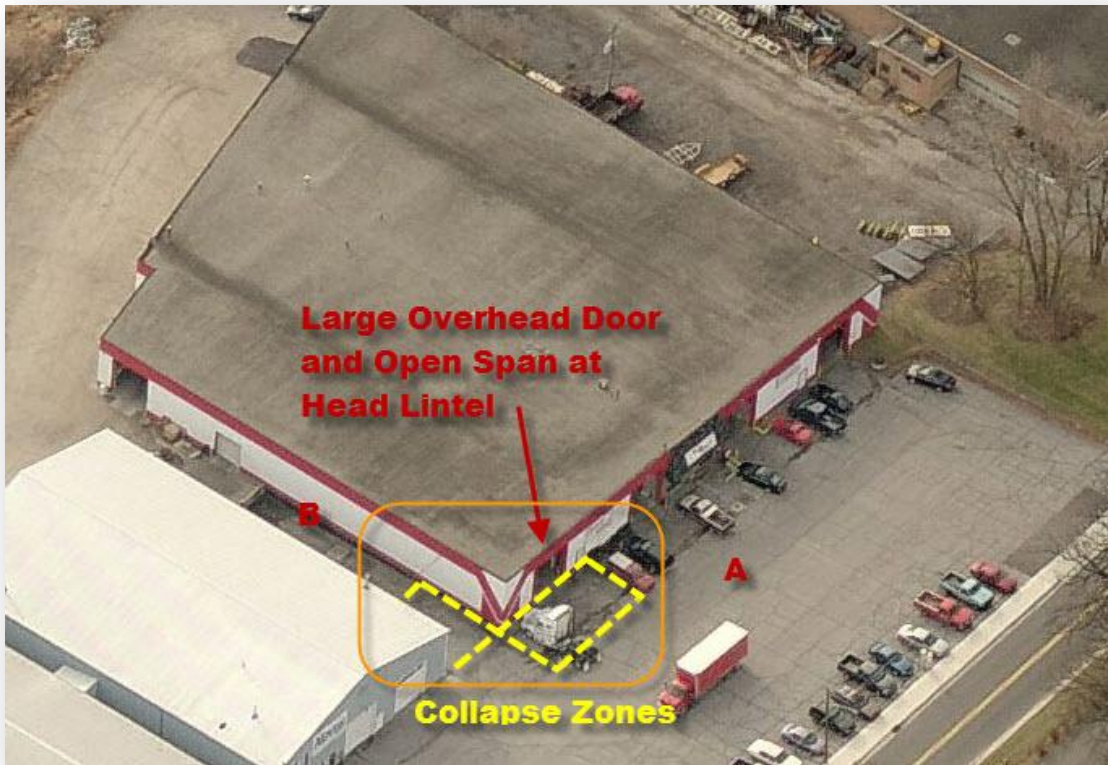
Alpha-Bravo Corner of Subsequent Collapse Aerial View

The view from the Alpha-Bravo Corner shows the collapse zones at grade and the affected area size.

As noted in the preceding narrative, the presence of the overhead door opening along the perimeter wall enclosure and outer envelope creates a risk area that would require monitoring, periodic reconnaissance and assessment during subsequent operations to determine structural stability and potential adverse conditions.

The proximity of the opening in relationship to the corner wall, roof support and structural span of the opening results in a very delicate balance of forces, loads, reliance and dependence that must be maintained for structural integrity and equilibrium.

- *The entire perimeter of the alpha side could be considered for a restricted collapse zone just in terms of wall opening alone sans the degree of actual or projected interior fire impingement or fire involvement.*

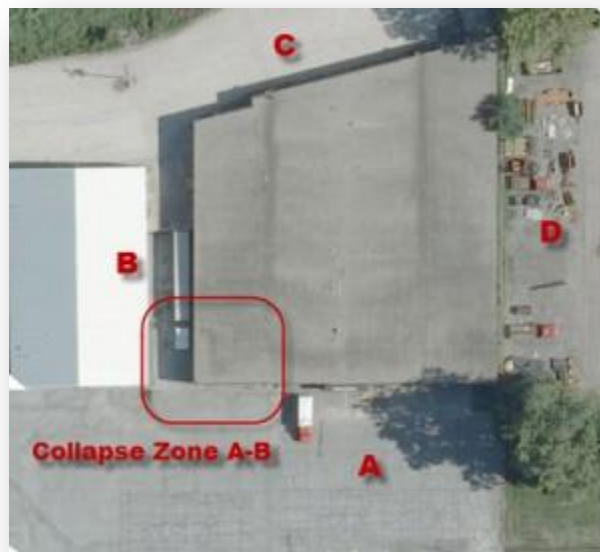
Aerial Overhead view of the building perimeter walls along the four divisions (A-D) with the A-B corner that subsequently experienced the wall-roof compromise and resulting collapse.

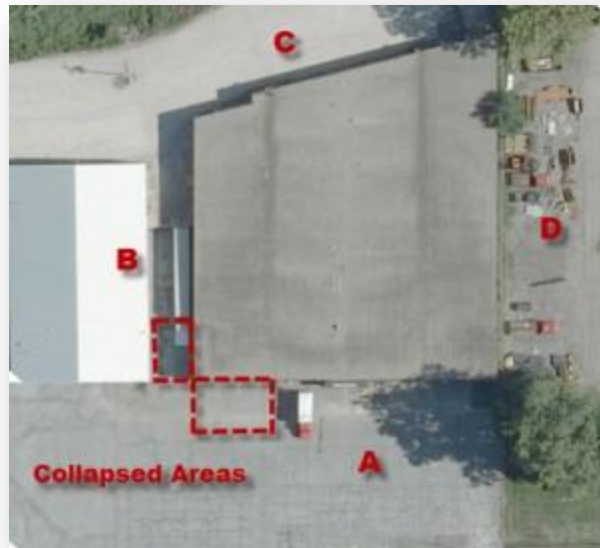
The A-B corner and the affected ground areas around the collapse zone. Considerations for a collapse zone area on the A-B corner would have resulted in a minimum distance of twenty five (25) feet from the building base for all operations within this area. The collapse zone on the Bravo side extends into the exposure building due to its close proximity.

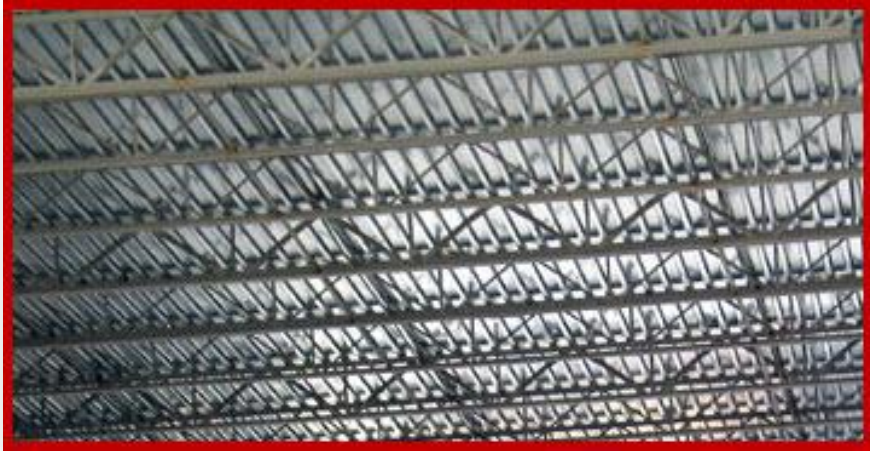
Typical Open Web Steel Bar Joists w Metal Roof Deck

Large clear spans provided by the open web steel bar joists allowed for considerable free floor space typical of commercial warehouse occupancies.

Note the use of what appears to be combustible wood storage and staging areas that could have potentially contributed towards increased fire intensity, extension and further contribute towards adverse effects on the unprotected structural steel components and assemblies.

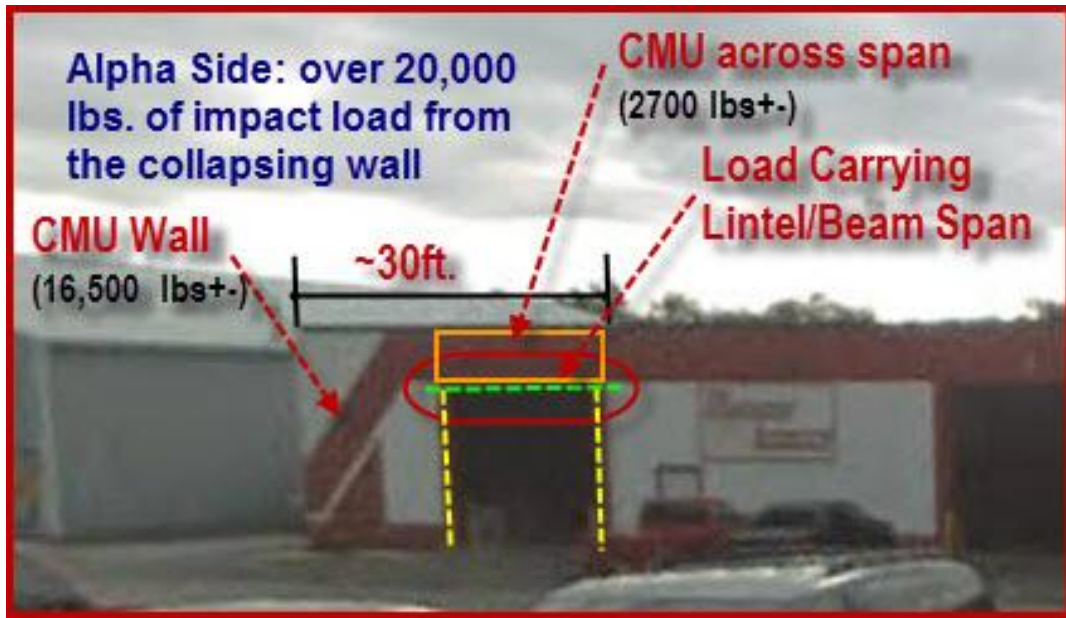
Alpha Side Collapse Area Details: OH Door Pre-Collapse Insights

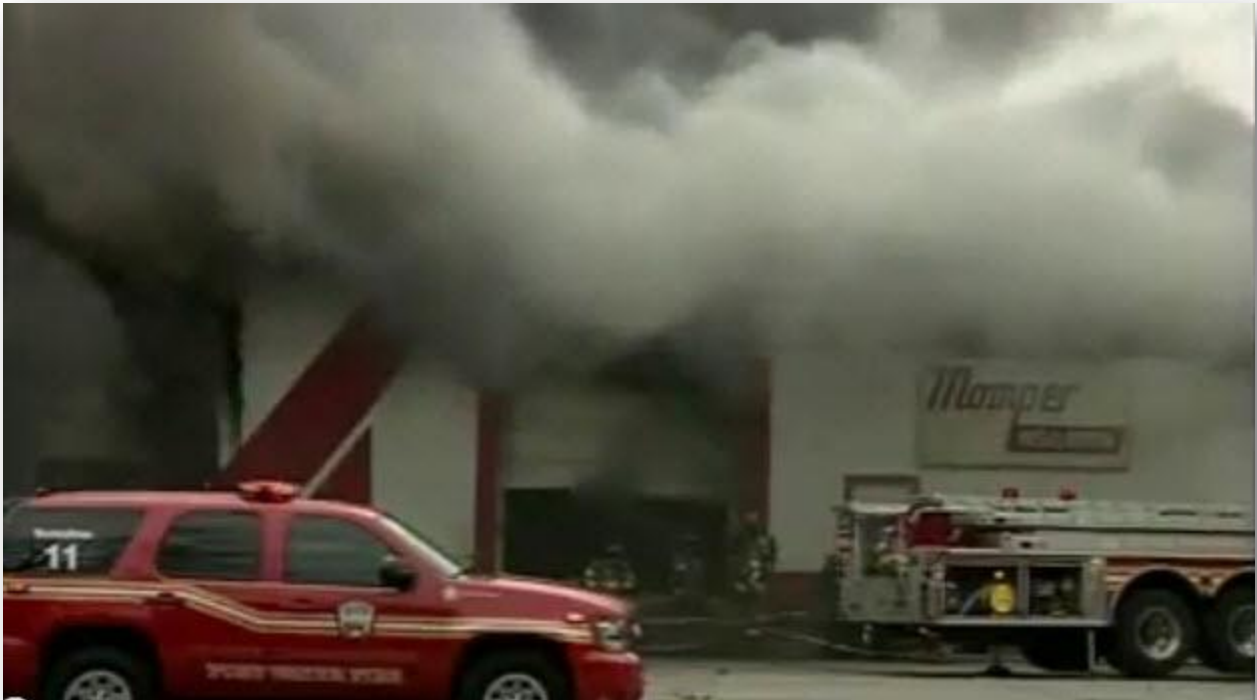
Pre-Collapse Operations on Alpha side with personnel in close proximity to the building perimeter

Pre-Collapse view of Operations on the Alpha side with personnel in close proximity, (within [a] collapse zone) to the building perimeter. It is evident that the degree of interior fire extension and involvement presumes a cautious deployment and placement of personnel in safe operational areas. When operating in such close proximity to the building wall and envelope, it becomes increasingly challenging for company officers and company personnel to monitor overall building performance indicators that may be prevalent or dominant from a view point further away from the building.

Fire extension, smoke conditions, component or assembly movement or displacement may be readily defined and identified from a vantage point away from the building, requiring additional independent operational assignments within the division if resources allow. Otherwise, officers are encouraged to get a big picture view and increase their span of vision of the building and progressing fire conditions and building performance

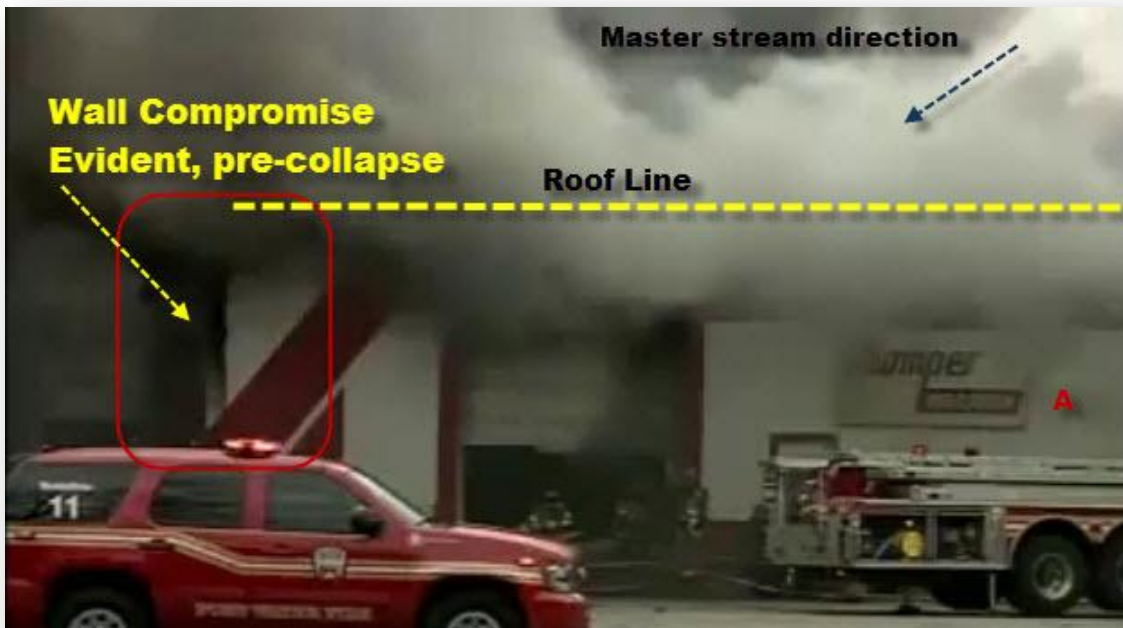
The pre-collapse frame image above identifies the building roof line in relationship to the ground operations, smoke conditions and also the directional flow of the elevated master stream [upper right corner]. The initial stage of the wall compromise and collapse can be seen in the Bravo wall pulling away. When watching the video, pay close attention first to the stream direction and flow and then at the location and movement of the wall, which is followed in rapid succession with the full wall collapse.

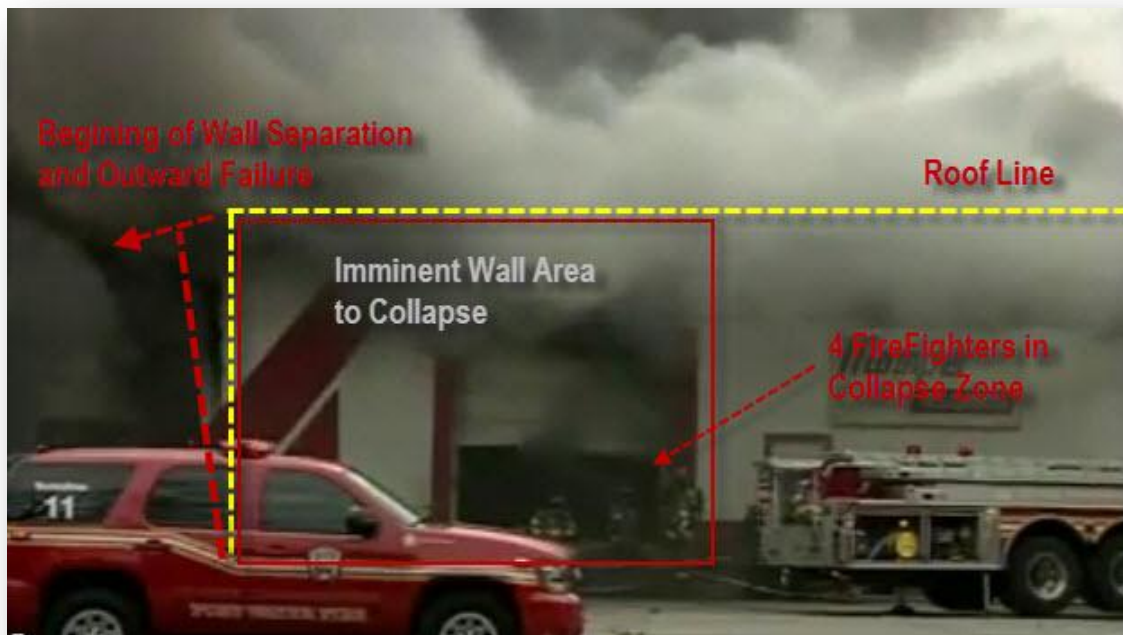
Close examination of the initial video frames shows the rapid displacement of the portion of the Bravo wall and outward collapse towards the B-Exposure (alleyway) Refer to the Aerial Plan for orientation. The A-B Collapse is progressing from the Bravo side to the Alpha side as loads are being transferred in rapid progression with further collapse expected.

The frame image above shows the bravo wall failing outward with the resulting loss in structural support of the roofing deck assembly.

Rapid fire migration and extension is evident after the wall section collapse with increased flames visible. In the video, one firefighter quickly recognizes the imminent collapse and reacts.

A significant section of wall area is present at the A-B side and progressing from the building corner to the left jamb of the overhead (OH) door. This area and the area directly above the OH door opening is calculated to weigh over 20,000 lbs.

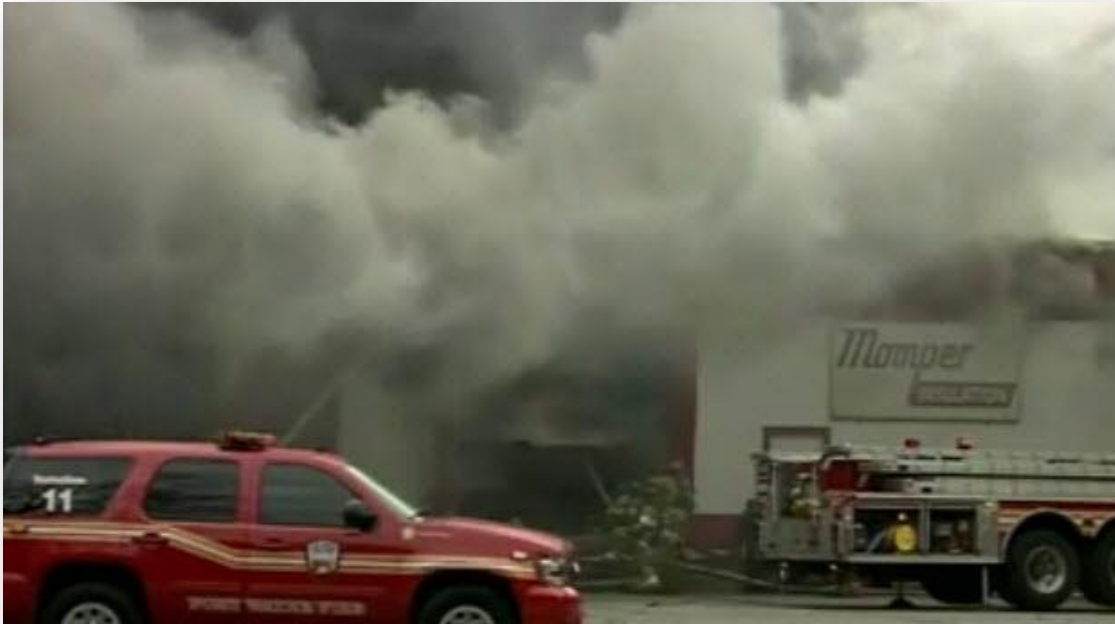
The image frame above shows personnel operating within an imminent collapse zone directing hand lines into the interior fire area. Further examination of the video frames clearly shows one firefighter quickly recognizing that a collapse is occurring and attempts to alert the other personnel to retreat. Simultaneously to the collapse progression, the crew immediately retreats away from the collapsing wall and falling building materials.

Within the span of four seconds, the wall compromise occurs and collapses on the ground at the A-B corner and immediate area on the alpha side. The slightly monolithic manner in which the wall plane first peels away and progressively collapsed is interesting for a CMU wall. Possibly due to the outward collapse of the Bravo wall, followed by the rapid succession of failure of the roof-wall connection interface resulted in a transitional downward force that pushed the alpha side wall outward allowing gravity to work its force

When operating in close proximity to a heavily involved forward interior condition [exterior position] it is important to maintain focused situational awareness and either directly maintain or delegate responsibilities for observations of fire and smoke progress and conditions while monitoring key functional building performance indicators and collapse pre-cursors.

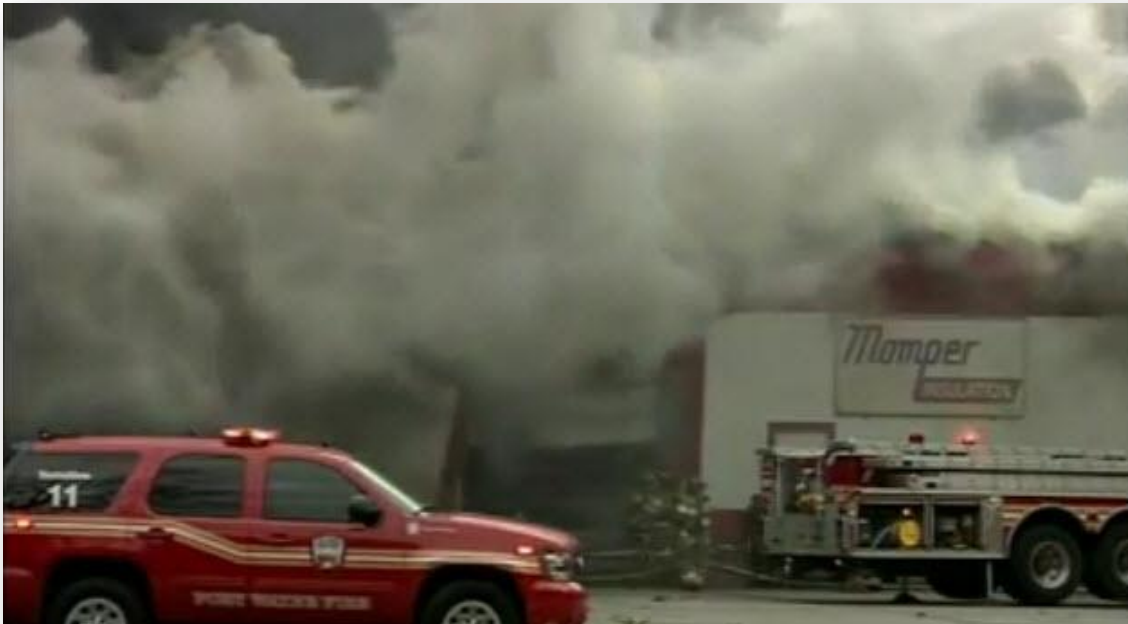
Image 04

Obscured by the rapidly defining smoke which is a result of the developing and extending collapse, the frame image 04 below depicts the beginning of the compromise and collapse sequence commencing as a result of the Bravo wall compromise and collapse sequence at the B-A corner that will subsequently peel towards the Alpha side and continue up to the outermost jamb of the overhead door.

Frame image 04 depicts the rapidly deteriorating conditions that are evident as the collapse sequence continues and the overhead door jamb (left) buckling and adjacent wall failing by way of an outward curl or peel away commencing from the upper (left image) A-B corner at the roof line and then peeling and failing from upper left to right.

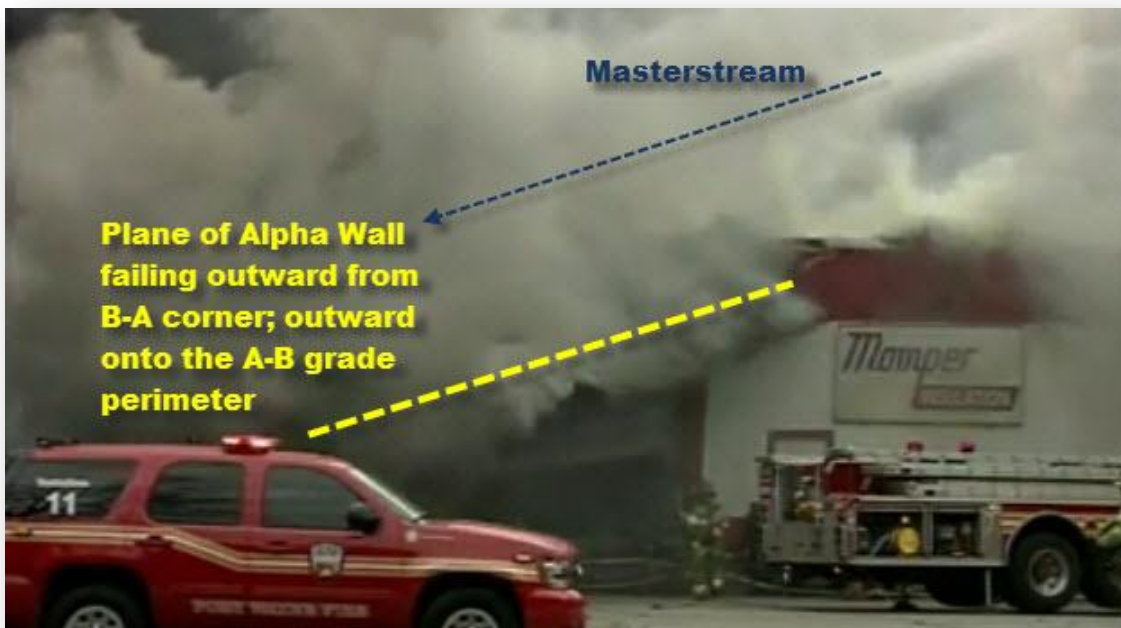
Image 05

The leading edge of the outward collapsing wall plane (yellow dotted line) is failing with the greatest material concentration occurring at the A-B edge outward. Fortunately the presence and location of the overhead door opening lessened the amount and location of wall material (concrete masonry units-CMU) and contributed to a void area being present and not fully impacting the firefighters who were operating within this collapse zone.

In other words, had this been a solid full wall collapse, the likelihood for significant firefighter injury would have resulted.

The effects of wall/roof compromise should be of focused consideration and monitoring when managing incidents of this size and magnitude in similar occupancies and building features. Flame and heat impingement can and will affect the structural integrity of lintels spans, beams and truss connection along roof lines and connections. Look for signs of impingement, degradation or compromise. Watch for signs of probable inward/outward or curtain- wall collapse.

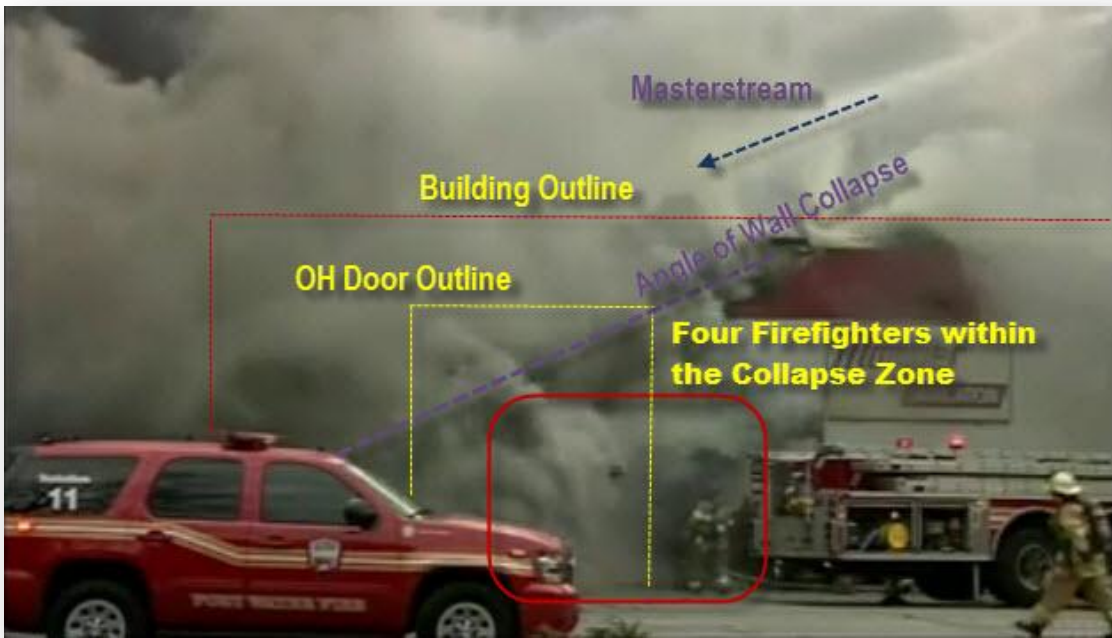
Image 06

The remaining images, frames 06 and 07 depict the location of the firefighters to the wall collapse, the relationship to the wall and roof system and the degree of wall area that became compromised and collapsed.
