Got Fire? Anticipate Collapse....

Christopher J. Naum, SFPE

Issued: November 9, 2011

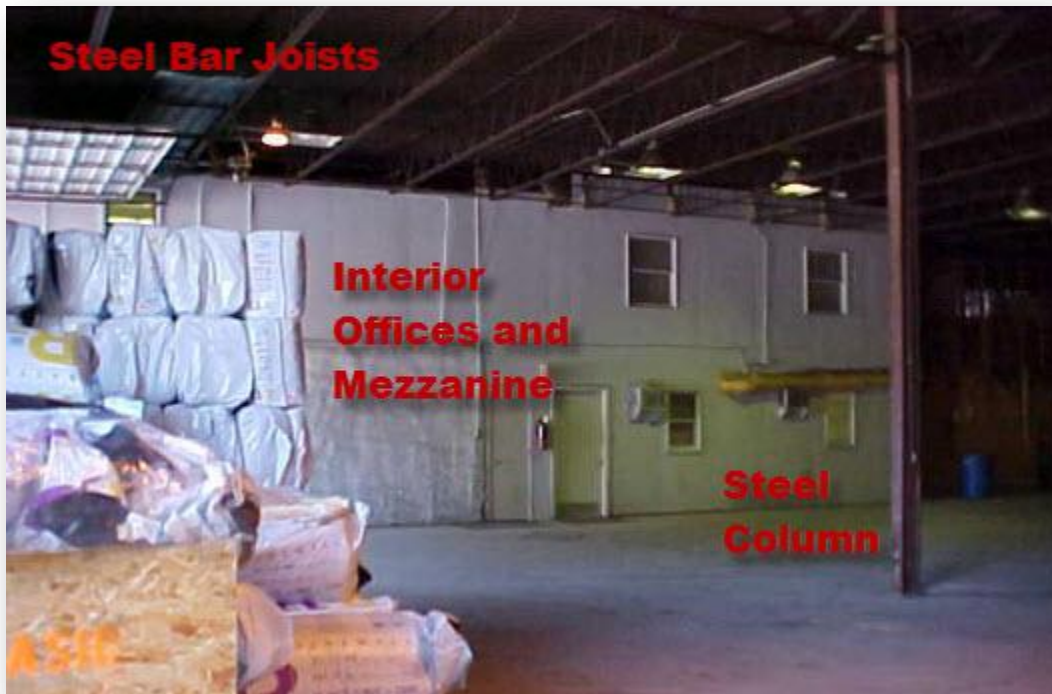
Typical Interior

The interior of the building included unprotected steel components and assemblies consisting of steel columns, beams and open web steel joists. These common and conventional structural support systems provided large free clear spans, common for typical warehouse and commercial occupancies.

The presence of unprotected steel components (Truss, column, structural beams etc.) and assemblies requires an understanding of the effects of flame and heat impingement, rate of heat release and fire dynamics, potential for movement and displacement of structural components and effect on assemblies, systems and connections and the effect on structural stability, integrity and building load transfers and displacement that all can adversely affect building performance, integrity and collapse potential
