Principles of Building Construction: Noncombustible

PBC:NC-Student Manual

2nd Edition, 1st Printing-April 2000

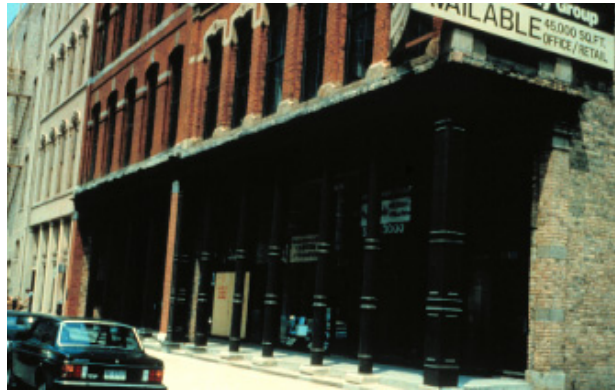
Cast-iron columns providing structural support for exterior wall

Cast iron was the first form of iron to be used as a structural element in buildings. Identified both for its strength under compression and a noncombustible material, it was first used in supporting columns around 1870. The columns could be manufactured easily at a foundry and transported to the construction site for installation. The forms used could be designed with a bell-shaped top and bottom to provide greater stability and still have heavy loads applied to them. Some early attempts to use cast iron for beams or girders were unsuccessful or had limited success, since cast iron has limited strength under tension or against shear forces. The problem with some of the earlier cast-iron materials was that, in many instances, they were not formed in a uniform manner. While the exterior of the column was uniform, the interior walls could be 1-inch thick on one side and 1/2-inch thick on the opposite side. Later, methods of pouring the forms with molten iron were improved and the quality also improved.

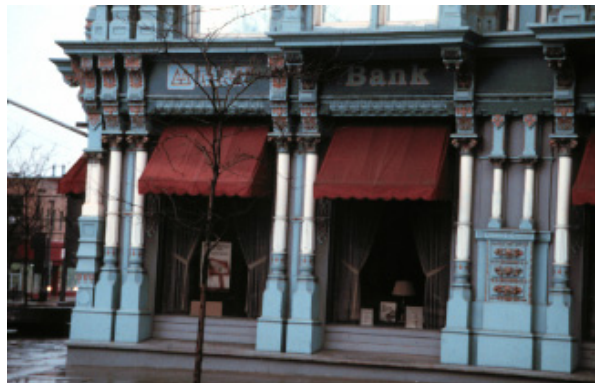
Cast-iron building front providing structural support to exterior wall of building

Cast iron could be formed to create arches and lintels to span window and door openings in walls, which provides greater flexibility to the building designer and the contractor installing the materials. Cast-iron lintels and arches typically replaced stone elements, which were much heavier and required extra strength in the load-bearing walls to carry the weight of the stone. Some attempts were made to create the complete building exterior wall from cast iron at a foundry, transporting the components to the construction site, and installing the pieces with bolts and rivets. Many such buildings still stand today, especially in the business districts of older cities.

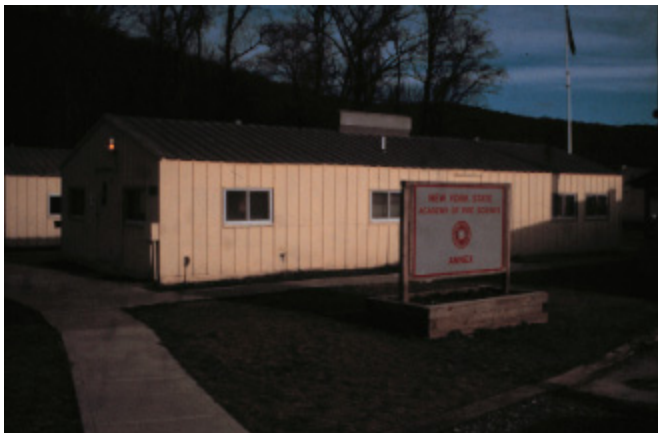
Lightweight steel construction buildings can be used for hundreds of different occupancies

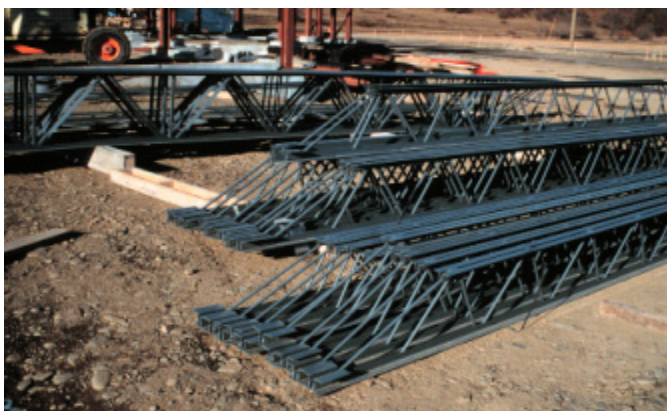
Steel bar joists are used to support floor and roof structural elements

Roof loads include a variety of loads that must be supported, ranging from the structural materials, snow or water loads (90 psi snow load requirement in upstate New York), heating and cooling equipment, compressors for refrigeration equipment, and the unexpected loads such as a company of firefighters assigned to a ventilation task during a fire. The most common structural material used to support the roofing materials is the lightweight steel bar joist. The bar joist is named for the steel bars that used to be formed in a "V", sandwiched support floor and roof loads between lightweight angle iron, and welded. The bars are usually 1/2 to 3/4 inch in diameter and the angle iron is typically 2 or 3 inches by 1/4 inch thick. Since the top is under compression it is the longer part of the element, and the bottom being under tension will not be supporting the beams or bearing wall. The "V" or "truss" principle provides the support from within the materials to carry the load and transfer it to the load-bearing elements such as beams and girders.

Roofing material for a pitched roof most typically will be sheets of corrugated steel attached to purlins that stretch across steel bar joists. Roof decking for a flat roof most typically is made from corrugated sheet steel attached to the steel bar joist, covered with a Styrofoam-type insulation covered with either asphalt paper and tar roof covering or a vinyl sheet roofing material. The roof then may be covered with round stone or lightweight patio-type masonry blocks that are used as foot paths over the roof so as not to damage the roofing materials. The Styrofoam insulation can produce a spongy or soft feeling when walking on the roof. This condition should be evaluated by firefighters to determine if the structural elements are weakened, or if the roof material is causing the soft feeling. While it would be preferred to have the roof elements identified on a building preplan, it may be necessary to make an inspection opening of the roof away from the fire area to determine the materials used. The roof elements will affect your ability to open a ventilation hole quickly.

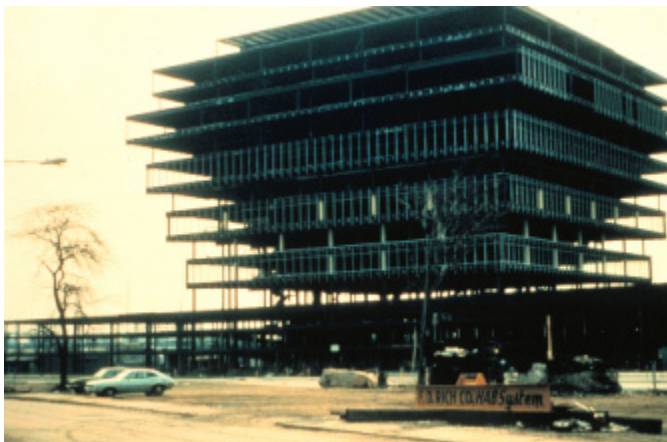
Multiple-story steel framework structure with limited or no special fire-resistance provided for the structural elements is considered an NFPA Type II Unprotected building

Steel skeleton frame buildings can be constructed two, three, or more stories in height. Each component of the structure is designed and installed so as to transfer the load to the ground. The entire building is only as strong as the weakest component of the framework. A frame of steel columns with steel beams attached to the columns creates a box-like support framework to support multiple floors and the roof. The framework starts in a fashion that is similar to the one-story structure with the steel column attached to a concrete pad and flanges which are attached to the columns and used to attach the beams that will extend to the next column. This same concept is used to create a framework for a two-story, three-story, or even taller building. In Module 4: Protected Noncombustible Buildings, this concept will be discussed when it is used to construct highrise buildings.

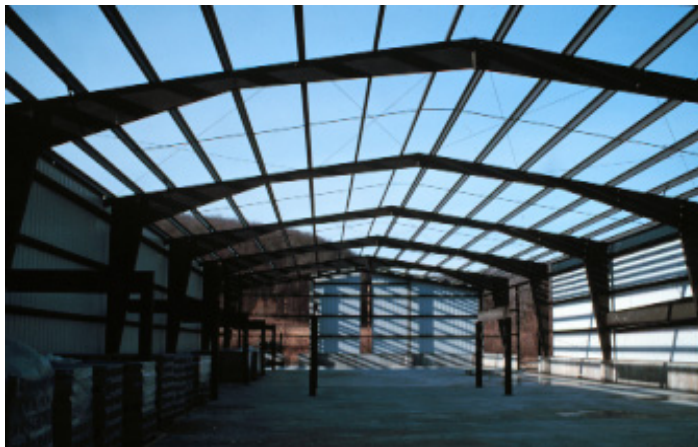
Rigid frame steel buildings use the arch principle to provide a clear span open floor space

The most common method of attaching a roof to a rigid frame building is to place lightweight steel bar joist from arch to arch. Corrugated steel sheet roofing then is attached to the steel bar joist. The roof elements are the lightest construction materials in the structural system and typically the first to fail under fire conditions. The structural arches made from substantial steel elements will absorb heat for a longer time before the materials start to relax, causing structure failure. One principle of this

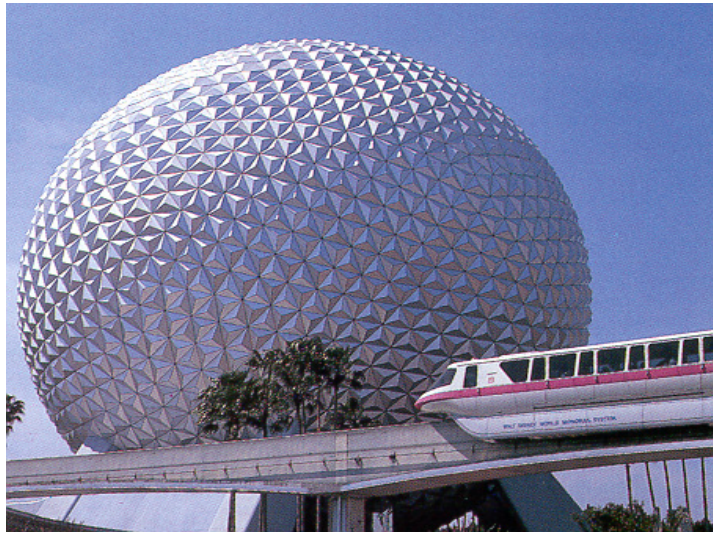
Steel frame geodesic domes are commonly used for entertainment purposes, special applications, or, in some instances, dwellings

Geodesic domes use a triangulation principle to form a lightweight structural framework that then can be covered with a lightweight covering such as aluminum or composite material. The triangulation of the framing materials works on the same principle of truss rafters that provide strength along their exterior surface to the ground support. Supporting interior loads is critical, since the structure typically is not capable of supporting additional loads, such as floors or floor loads. Typically, floor loads would be supported with columns and beams.

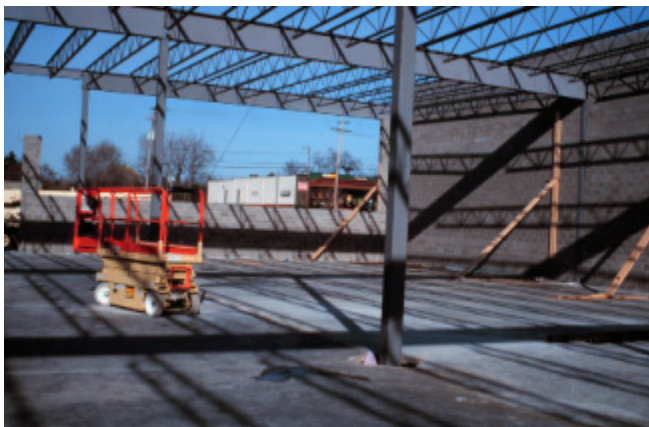
Steel columns of a box skeleton frame structure may be incorporated into a masonry wall, which also may provide support to the steel bar joist on the exterior wall

The steel box frame or rigid frame building typically does not rely on interior walls for structural support. Interior walls are typically non-load-bearing, and simply are used to segregate areas of the building. Exterior walls enclose the structure and, in some instances, may provide fire-resistance as the steel columns may be incorporated into masonry walls during the construction of the wall. Another construction technique is to use masonry exterior walls to provide support for the steel bar joist on the exterior of the structure, especially if the building is to be only a single span (one bar joist truss) floor or roof element. A masonry wall on each side of the building supports the roof or floor elements above.

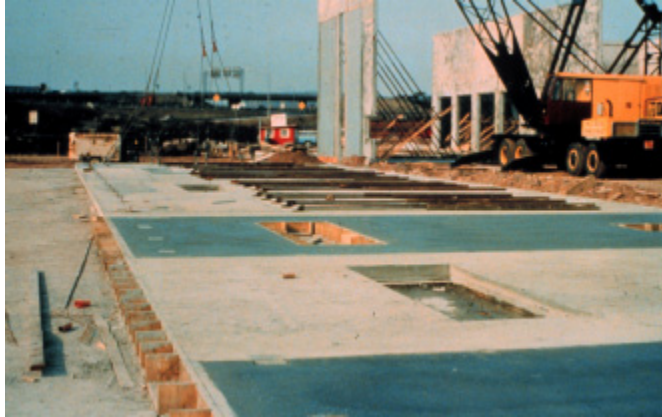
Poured-in-place concrete walls are tilted up once the concrete is cured and, once in place, often provide support for the steel bar joist roof supports

Many noncombustible buildings use a combination of masonry supports and structural steel. The masonry can be concrete block, poured-in-place concrete, or concrete panels prefabricated at another location and brought to the construction site. In some instances the concrete walls actually are poured and cured at the construction site adjacent to the position where they will be placed on a foundation. They are simply tilted up and secured in place after the concrete is cured.

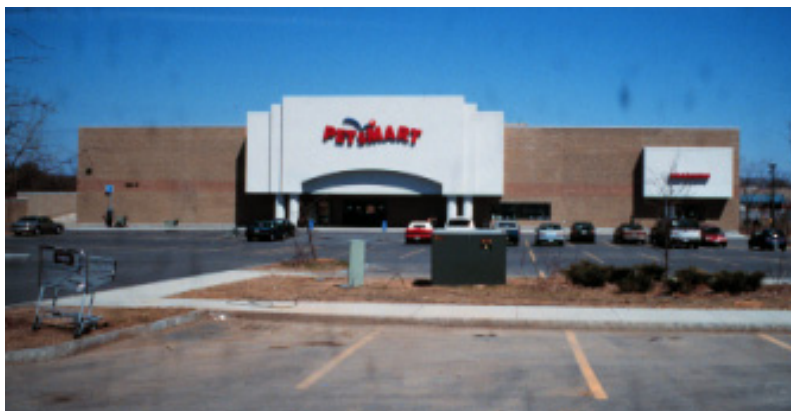
The "big box" structure is common today in nearly every community

The "big box" store is common today, and is used for many different occupancies. Chain lumber and hardware stores, office supply stores, and numerous other commercial operations use the big box building. The term "big box" comes from the many box-like structures created by the beams attached to the tops of the columns and when viewed from the top, it appears as many square steel boxes which will support either a floor system or, most commonly, a roof system.

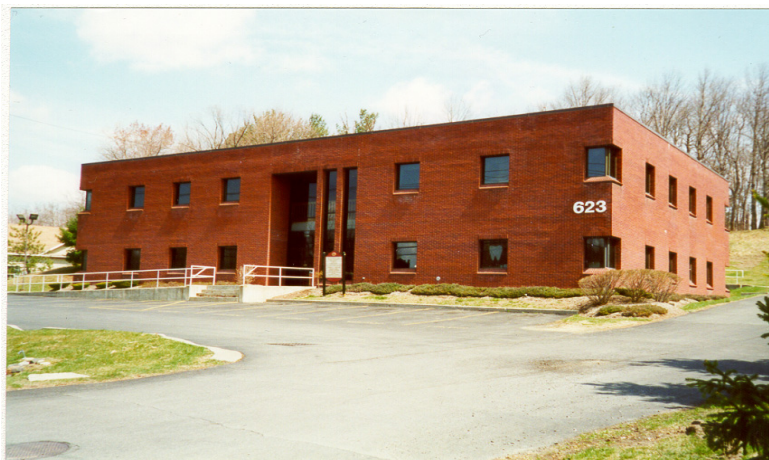
Protected steel frame structure

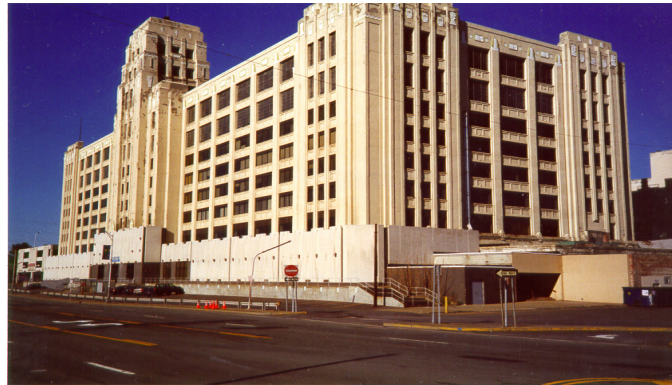
Concrete framed structure

Reinforced concrete structures became popular after the first modern structure was formed and poured in 1903. Concrete construction gained in popularity from 1920 to 1940, when cities started to grow using concrete to build buildings taller and bigger. Since buildings constructed during this era did not have air conditioning, it was necessary to arrange the floor plans so that rooms had exterior windows that could be opened for ventilation. Typically over the entrance door to the office or apartment was a small window called a transom. The purpose was to allow an opening high on the interior wall that would allow for cross ventilation, with the cooler air coming at the lower exterior windows and the warm air
